CONESTOGA TELEVISION ASSOCIATION
Lancaster, Pennsylvania

Technical Report

TELEVISION RECEPTION FROM W3XPR - SUMMER 1948

September 13, 1948

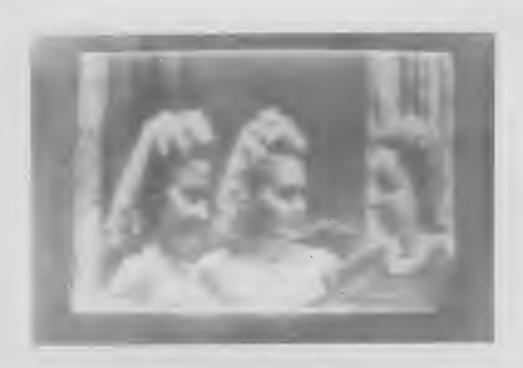
## Photograph of Picture Received at the Penthouse

This picture shows noise intermediate between Hoffmann's end Richards' locations. Hoise may be noted on the background. Several frames were required to expose the film so noise is somewhat integrated out. Here again the true character of the noise is not well presented by the photograph. Conditions such as vertical linearity were not considered in arranging for this photograph.

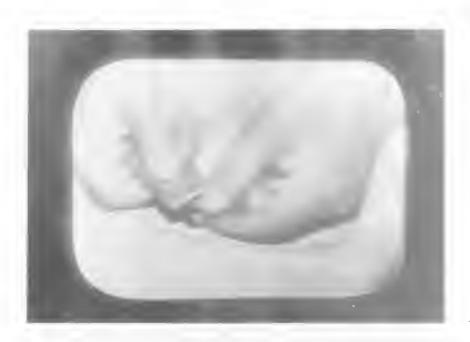
Photograph of Picture Received at Hoffmann's Residence

Exposure time of a few frames was used to give a true indication of noise. Observers of this picture insist that the photograph does not do the televised picture justice.

The new transmitter was used (Report No. 54).
